Hanalei Stream Bank Restoration Project and In-Water BMP Design

Introduction

- **Noah Wong, PE**
Civil Engineer
AECOM
noah.wong@aecom.com

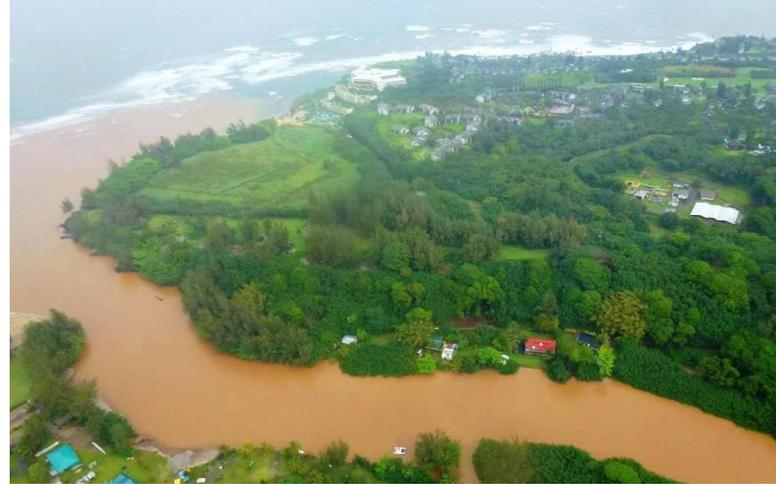
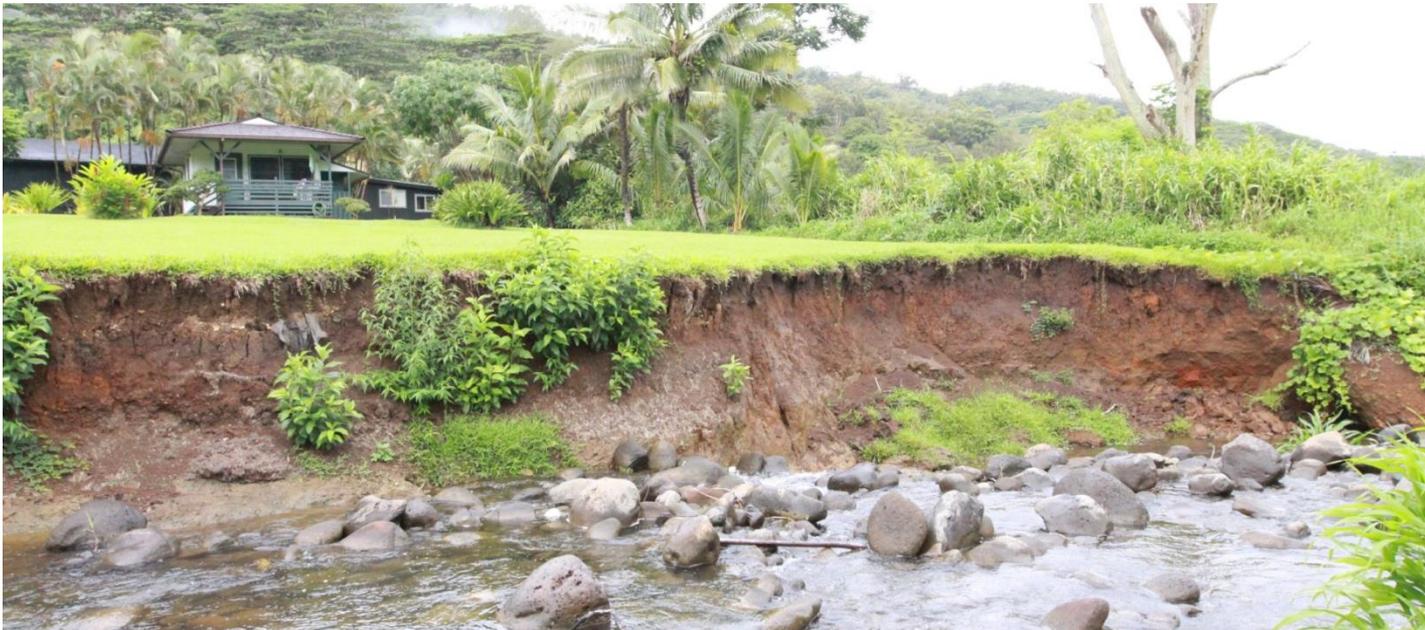
Soil Erosion

- ❑ Erosion along breach channel has deposited an estimated 28,000 tons of sediment into Hanalei Bay.

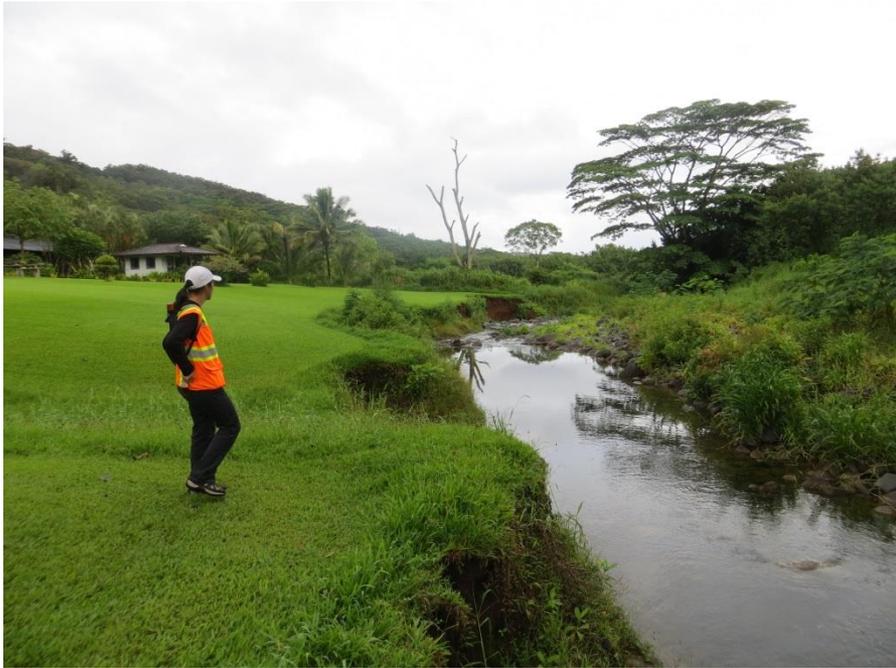
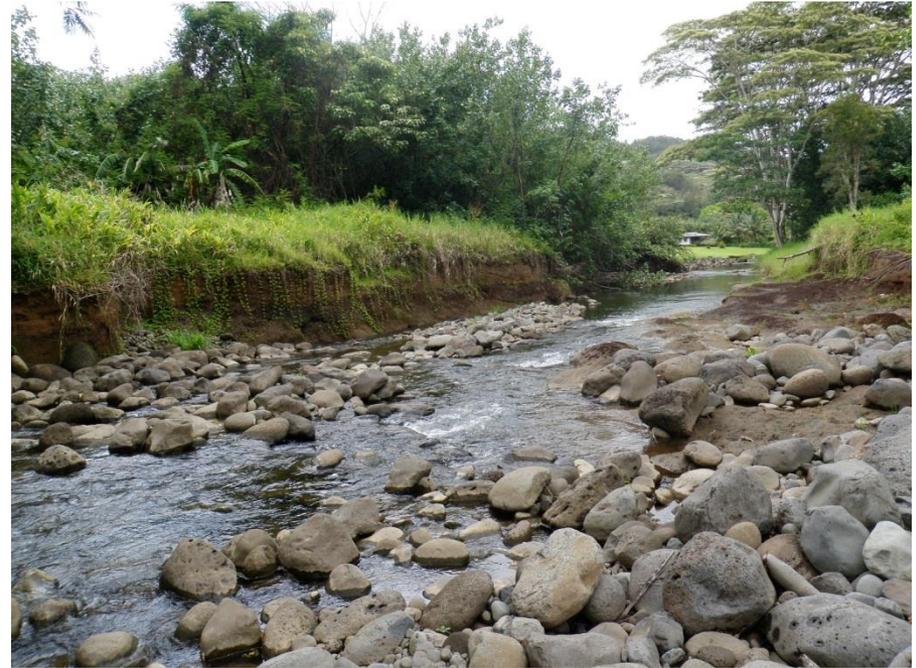
Breach Channel

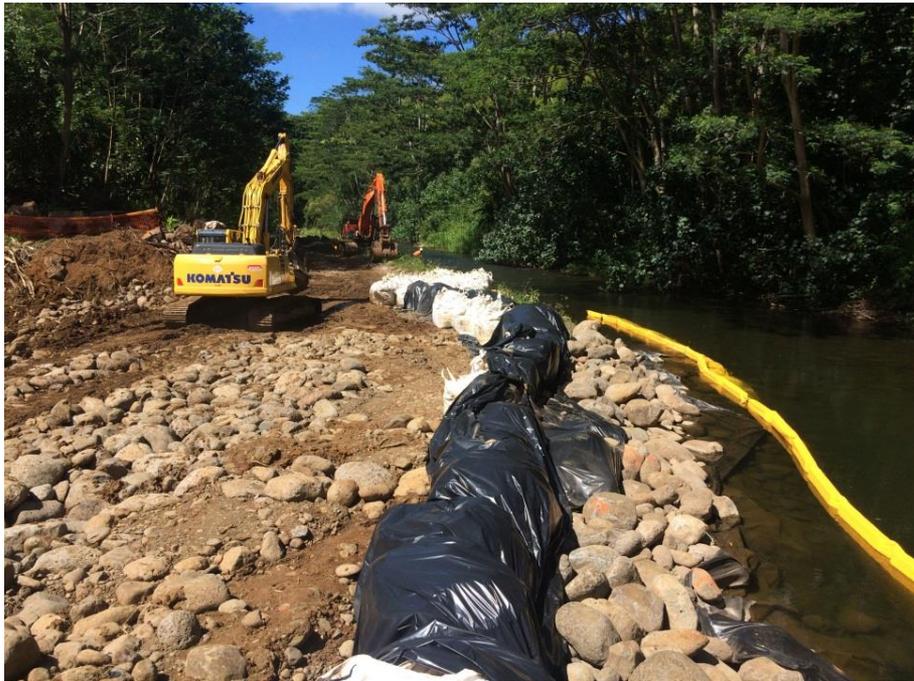
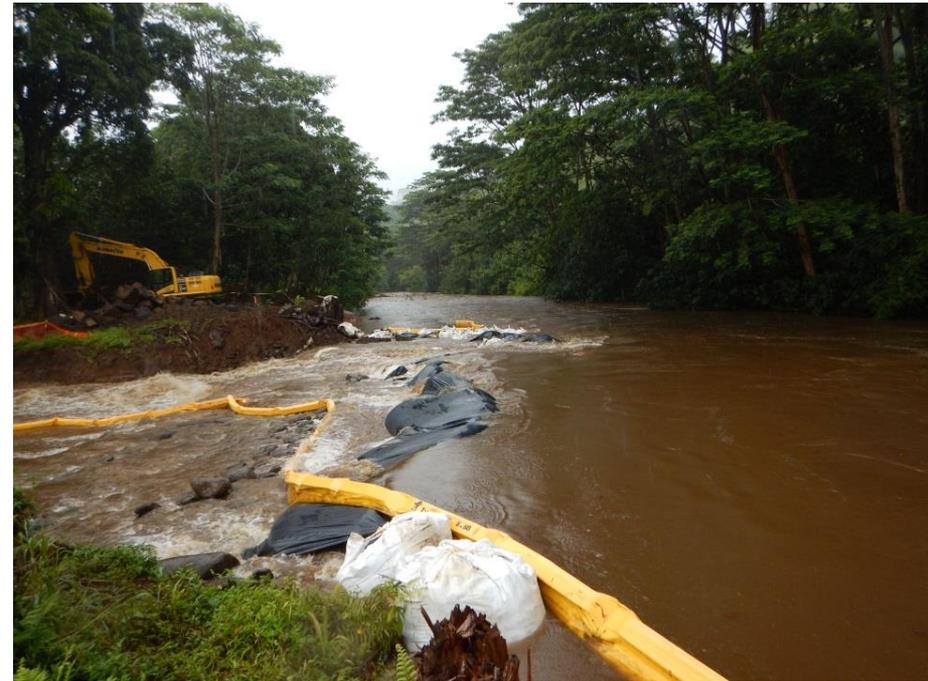
June 2015 storm event
