HONOLULU COMPLETE STREETS IMPLEMENTATION STUDY LOCATION REPORT

Kapahulu Avenue from Kaimuki Avenue to Date Street (FINAL)

City & County of Honolulu
Department of Transportation Services

Prepared by
SSFM International

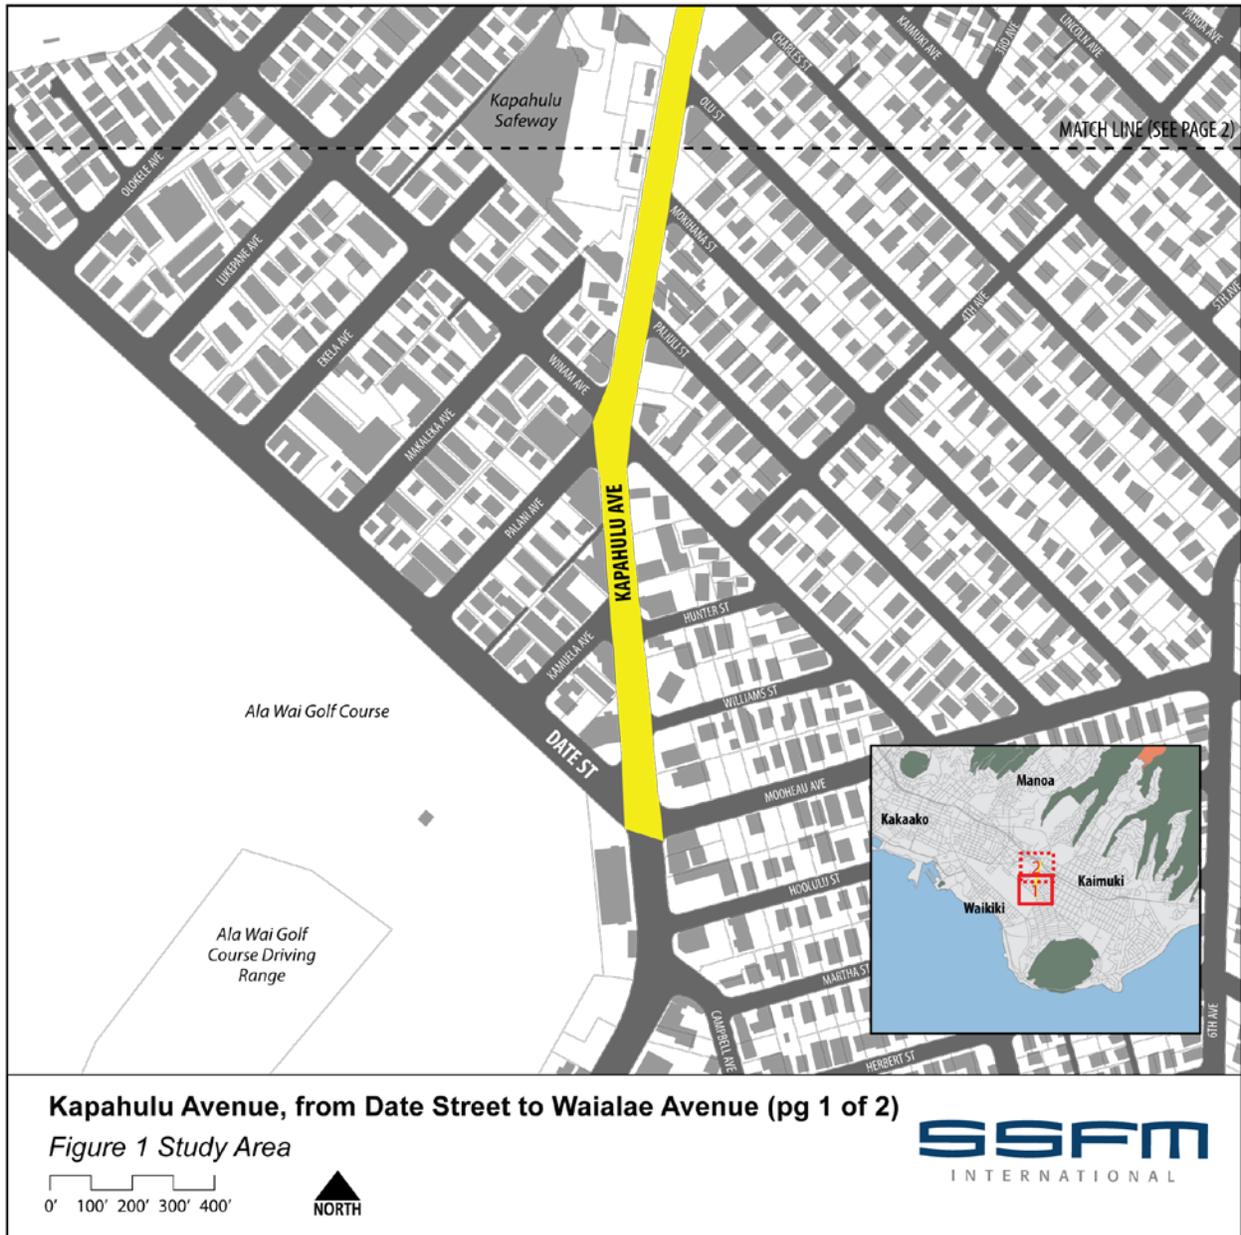
Figure 1 Makai Study Area from Date Street to Olu Street

The subject location of this assessment is Kapahulu Avenue from Date Street to Kaimuki Avenue. The site lies in the Primary Urban Center Planning Area, in the Kapahulu Sub-Area, which is part of Council District V. Kapahulu Avenue is a major mauka-makai connection running from the Diamond Head (east) side of Waikiki to H-1. The section under discussion in this project runs through dense residential neighborhoods and is lined with small-scale retail. One major shopping center, between Paliuli and Olu Streets, contains a Safeway grocery store and parking structure, which attracts a high number of trips. Figures 1 and 2 show the study area.

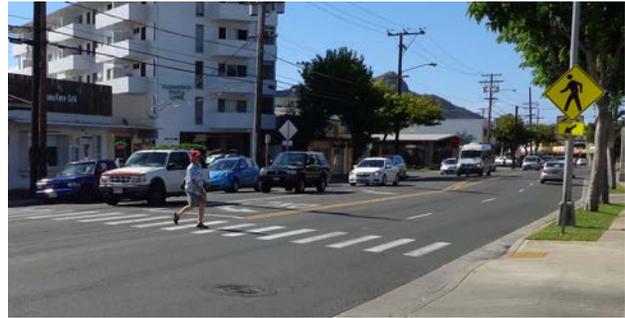
Many unprotected and uncontrolled crosswalks impede safe walking on Kapahulu Avenue. Here, pedestrians must rely upon five lanes of traffic coming to a stop in order to cross safely.

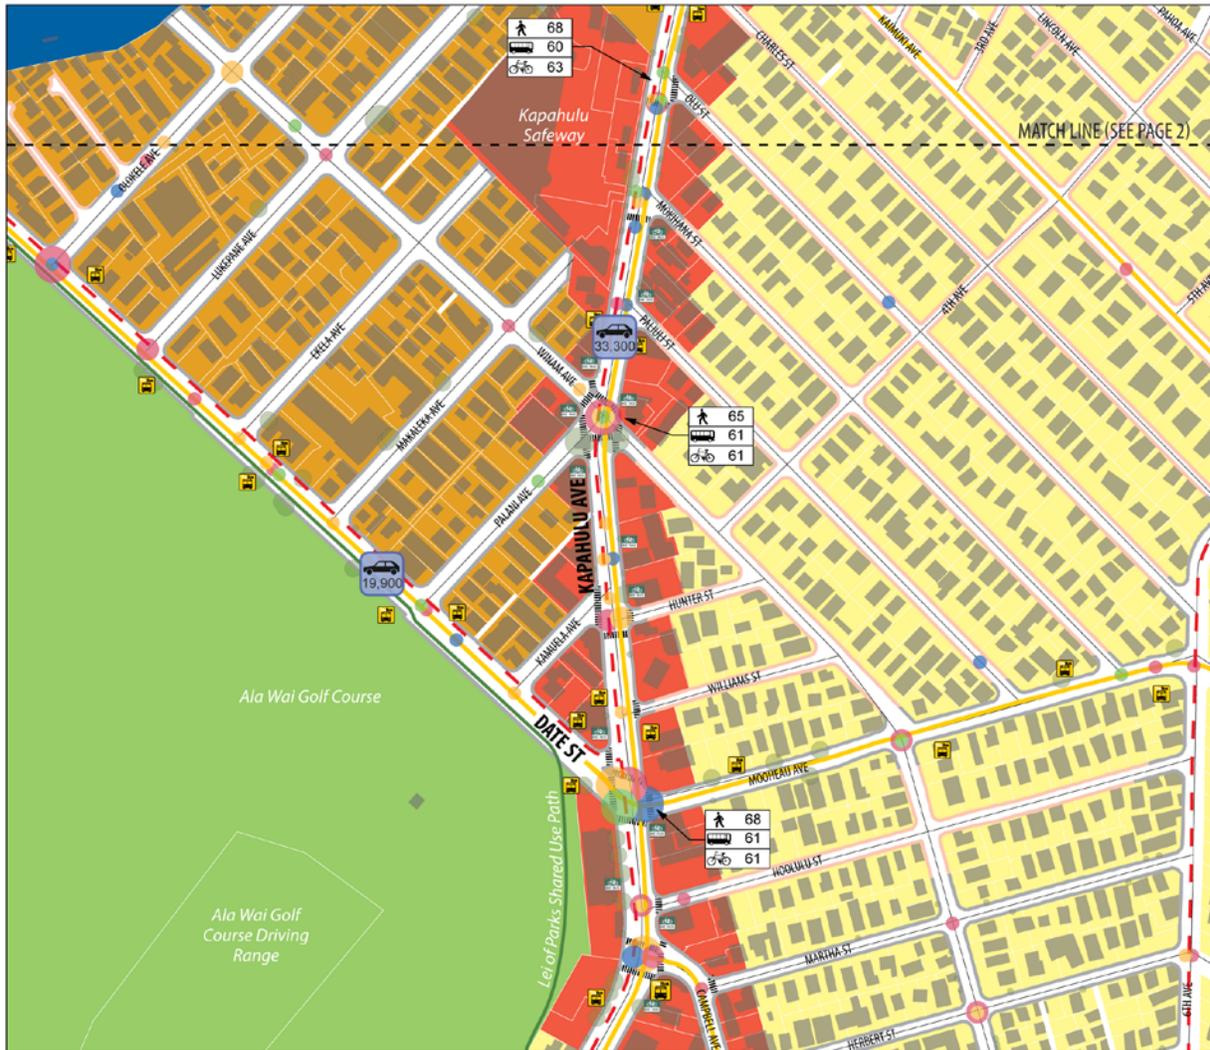
Figure 3 Existing Land Use, Transportation Facilities, and Accidents in the Study Area from Date Street to Olu Street

Figures 3 and 4 depict existing land use, transportation facilities, and traffic accident data within the study area. Kapahulu Avenue is entirely zoned for commercial use. Behind the commercial uses on the Diamond Head side, uses are primarily single-family residential. Multi-family residential exists behind businesses on the Ewa side. Major destinations include the Ala Wai Golf Course, Waikiki-Kapahulu Public Library, University of Hawaii, Chaminade University, St. Louis High School, the shared use path at Date Street, Safeway, and Crane Community Park. Walk scores, transit scores, and bike scores are all around the low to mid 60s, which indicate a moderately favorable environment for these modes of transportation¹.

In general, Kapahulu Avenue consists of two lanes per direction. In some areas, a dedicated left turn lane also exists. Pockets of on-street parking are scattered along the street, although parking is lightly used since many properties have dedicated off-street parking.

The diagonal alignment of Kapahulu Avenue results in several skewed intersections with excess space, including at Date Street, Kamuela Avenue, and Charles Street. One large five-leg intersection exists at the junction of Winam Avenue, Palani Avenue, and Kapahulu Avenue.

Marked crosswalks are generally appropriately spaced, with crossing opportunities every 300-400 feet. Not all marked crosswalks are controlled with stop signs or signals, meaning pedestrians must wait for four lanes of heavy bi-directional traffic to stop at uncontrolled locations before crossing.

During a four-year period, 82 total accidents have occurred along the study area. Of these 82 accidents, 11 involved bicycles, and 10 involved pedestrians. The most traffic accidents have occurred at Kapahulu Avenue and Date Street, a high-volume skewed intersection at the edge of Waikiki.

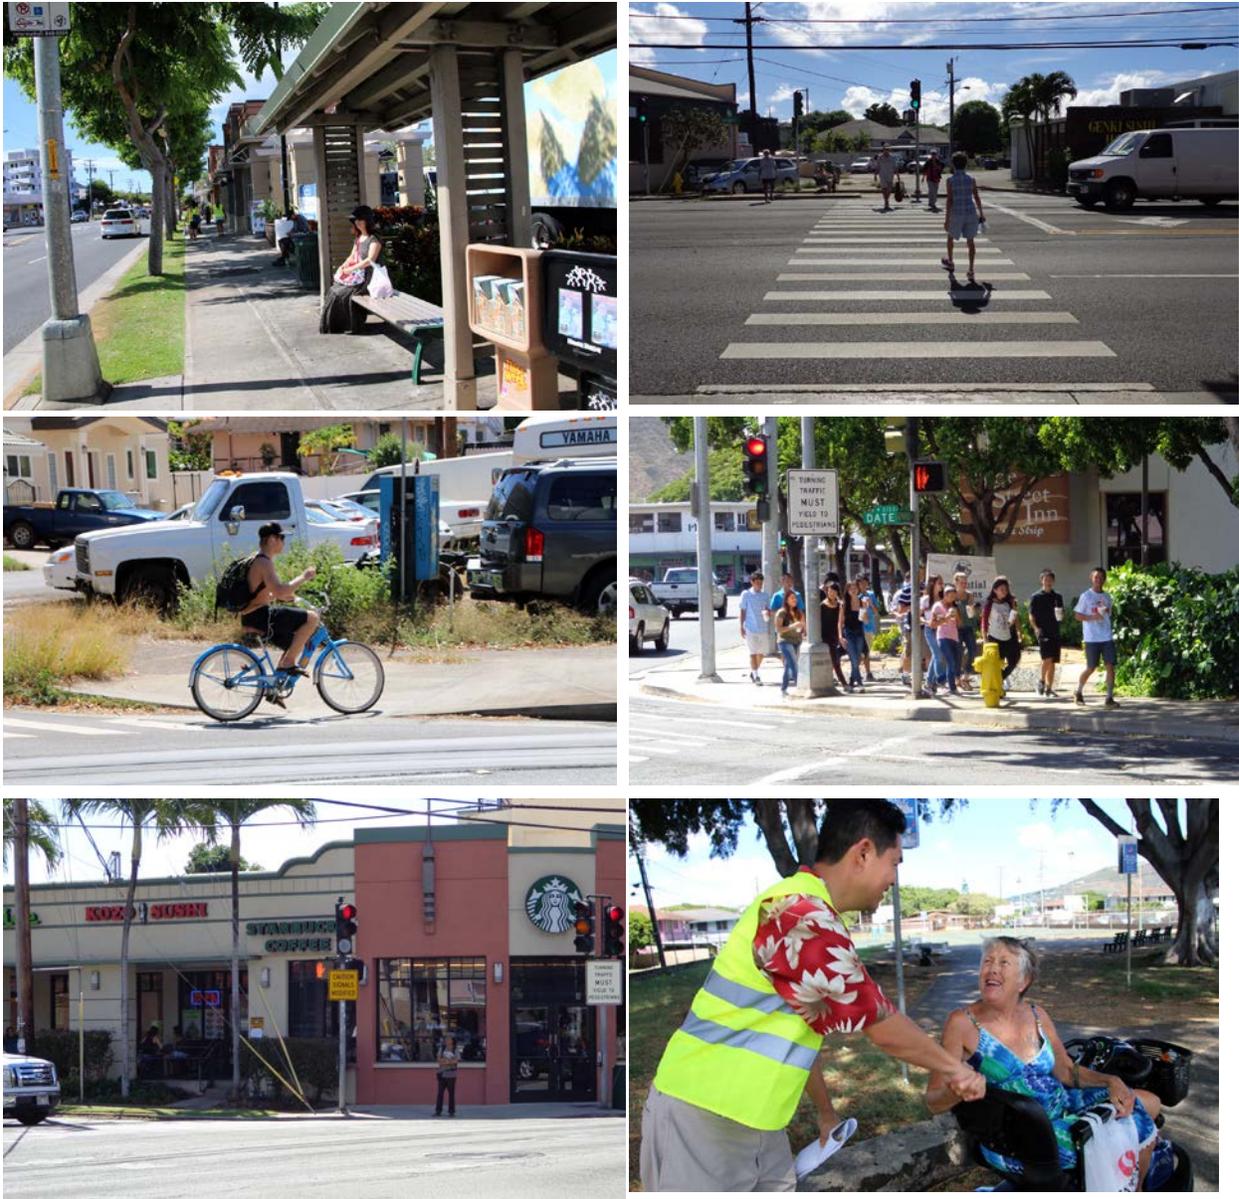
During the walking audit of Kapahulu Avenue, many people were observed walking, bicycling, and using transit. Photo descriptions clockwise from top left: Woman waiting at a transit stop with amenities such as a covered shelter, bench, newsstands, and trash receptacle near Safeway; Pedestrians crossing at a signalized marked crosswalk location; Group of teenage pedestrians observed at Date Street; Person using a wheelchair along the street; Numerous commercial businesses fronting the sidewalk along Kapahulu Avenue; Person riding a bicycle on the sidewalk.

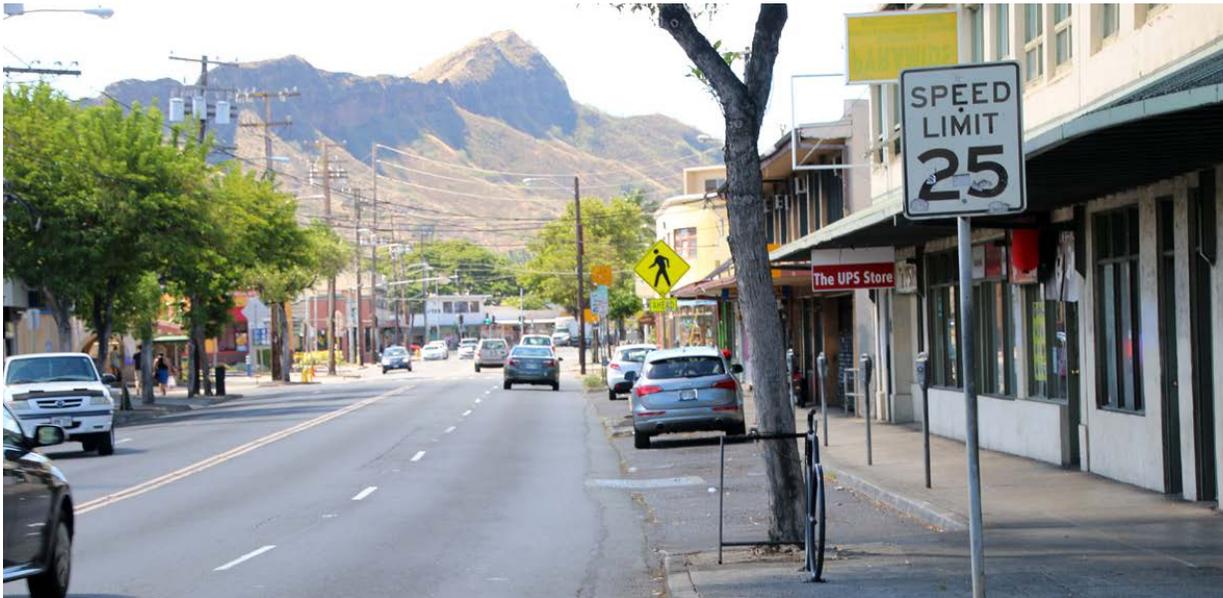
The posted speed limit is 25 mph. Although in some sections Kapahulu Avenue is narrow (40 feet) the distance between signalized intersections is long, especially along the mauka end. This results in the perception of a high-speed travelway.

Vehicles travel faster than the posted speed limit as a result of the built environment.

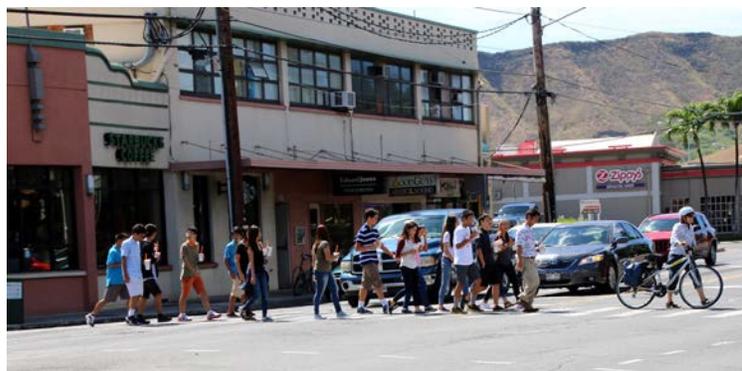
Many pedestrians frequent Kapahulu Avenue and its crosswalks (Photo taken at Kapahulu Avenue and Mooheau Avenue).

During the walking audit, a steady stream of pedestrian traffic was observed. Pedestrian activity was lighter closer to H-1, but otherwise the street is well-used by those on foot. Complete Streets aims to leverage this current activity through street improvements that bring about more walking activity, economic development, and community health.

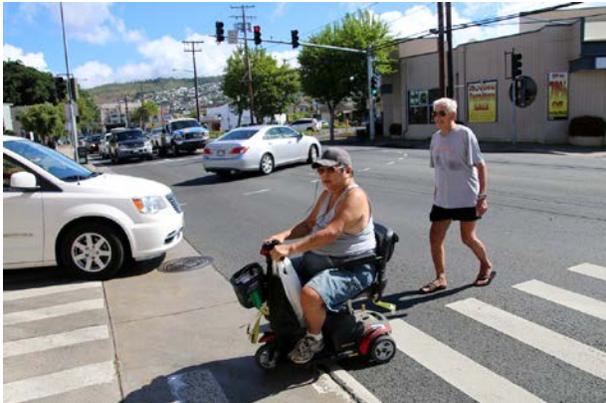
Elderly and disabled pedestrians crossing in the marked crosswalk at Kapahulu Avenue and Olu Street.

More so than in other walk audits conducted, a notable frequency of older adult users and people in wheelchairs or using other mobility devices was observed. In areas with high pedestrian usage, ADA-compliant curb ramps (two per corner), tactile warning strips at intersections, and safe street crossings are a higher priority. This is especially true if many pedestrians are elderly or disabled. In addition, elderly and disabled take more time to cross the street and therefore require longer pedestrian phases.

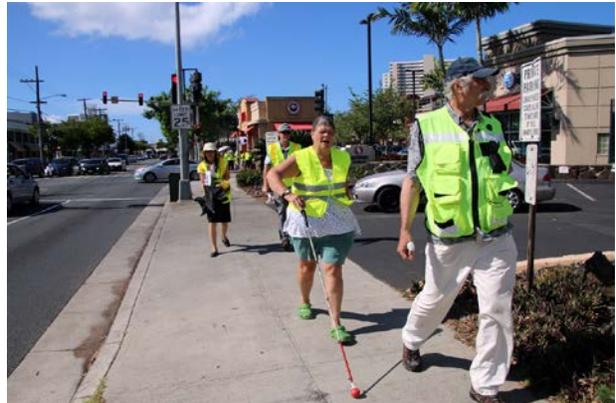
The placement of tactile warning strips at driveways and curbs help direct the visually impaired.

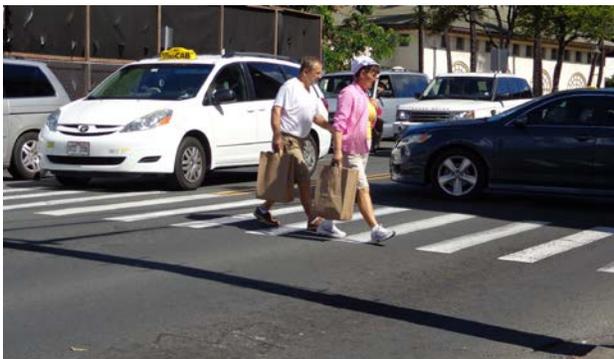
Some marked crosswalks across multi-lane roadways lack pedestrian safety facilities such as median refuge islands or advanced stop lines.

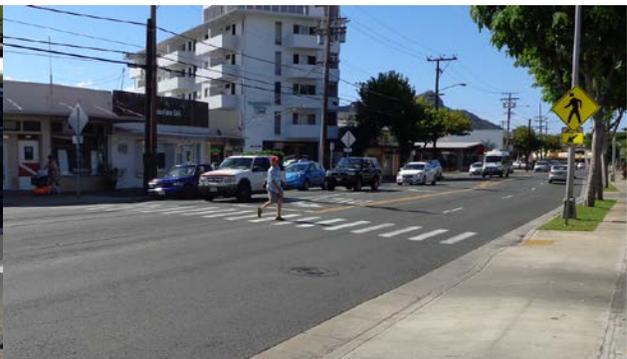
Placing traffic control devices, median refuge islands, or stop lines will greatly improve pedestrian safety (Kapahulu Avenue at Mokihana Street).

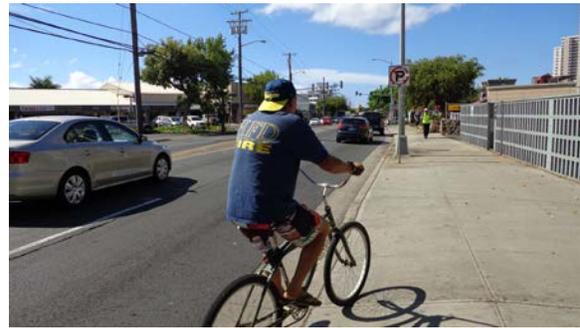
High vehicle volumes and speeds discourage cyclists from riding in the road.

More than 300 cyclists traverse Kapahulu Avenue each day. Given the high vehicle volumes and speeds, only fearless cyclists share the road with motorists. Instead, most cyclists choose to use the sidewalk. In areas with heavy pedestrian travel, cyclists were generally observed riding slowly to avoid conflicts. As a major direct route, Kapahulu Avenue should have dedicated bicycle facilities. This will help attract more cyclists and make sidewalks safer for pedestrians. Enhanced bikeway infrastructure such as bike lanes or protected bike lanes should be considered as a part of future improvements along the whole corridor however the constraints of this project area do not lend themselves to spot improvements that aren't connected to existing bike facilities.

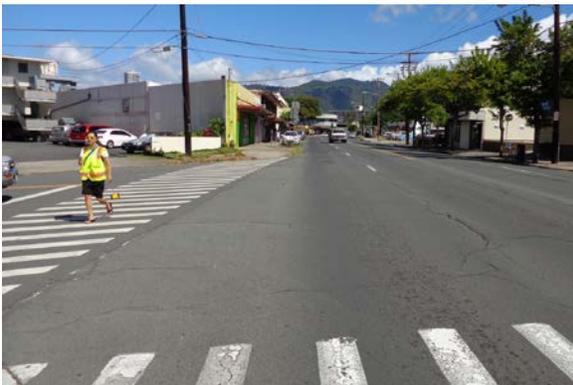
The crosswalk at the intersection of Kapahulu Avenue and Kamuela Avenue is more than 80' long.

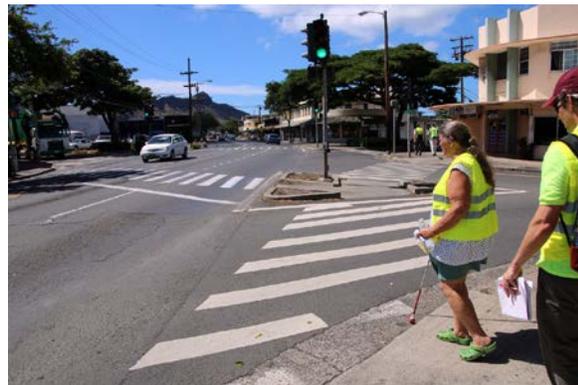
Channelization islands reduce pedestrian exposure to vehicle traffic (Kapahulu Avenue and Winam Avenue).

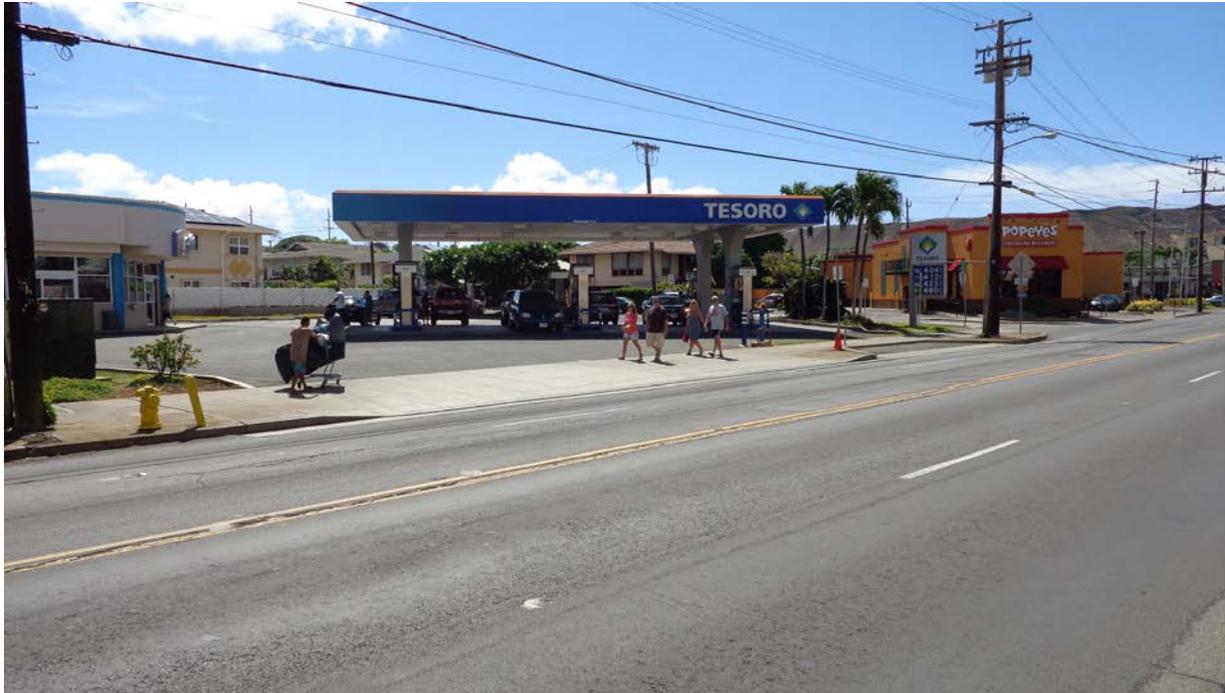
The Tesoro Gas Station driveway on Kapahulu Avenue is about 50' wide.

Kapahulu Avenue is a commercial district lined with small and large businesses. Most parcels have dedicated off-street parking for customers and a separate driveway. Driveways introduce conflicts for all users including drivers. They cut across the sidewalk zone and reduce the space for pedestrian amenities such as street trees, benches, public art, wayfinding signage, and other amenities. In many cases, driveways are so close together or so wide that they appear dominant over the sidewalk.

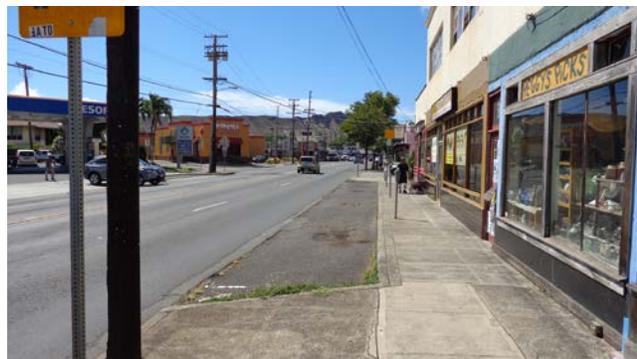
In many locations, on-street parking stalls are cut into the sidewalk (Photo taken at Kapahulu Avenue and Kamuela Avenue).

In several locations along Kapahulu Avenue, the sidewalk is cut in to provide metered on-street parking. Since most businesses along the street provide customer-specific free parking, this metered parking is not crucial for businesses. Some parking spaces could be reallocated to streetscaping, parklets, or bike corrals. In the long-term, if driveway consolidation and additional development produces more parking demand, stalls can be retained for customer parking.

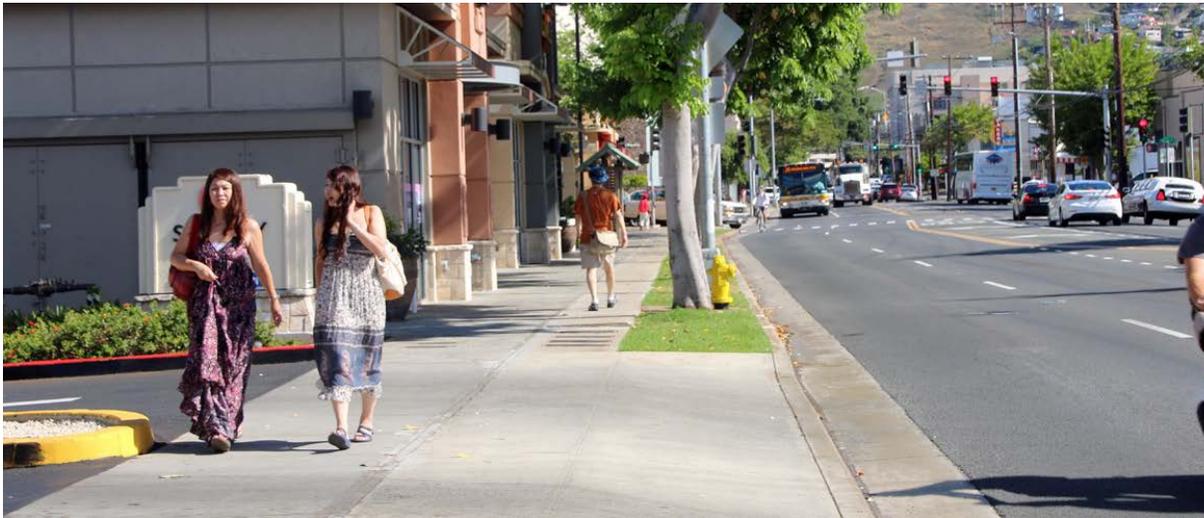
Pedestrians cross an appropriate driveway design in front of Safeway on Kapahulu Avenue.

- Enhance walkability by closing driveways in cases where one land use has more than one driveway.
- Enable shared off-street parking to reduce parking supply and driveway demand.
- Ensure that driveway design makes the sidewalk dominant over the driveway by keeping the sidewalk at sidewalk level (rather than sloping down), maintaining concrete sidewalk pattern across the driveway, and minimizing driveway width. For a one-way driveway, ensure width is no greater than 14'. For two-way driveways, ensure width is no greater than 24'.
