## ALTERNATIVE 1: Rehabilitation of the Natatorium, including the pool structure

## ALTERNATIVE 2: Retention of Bleacher Structure with No Landside Modifications

## ALTERNATIVE 3: Beach Creation with Landside Modifications

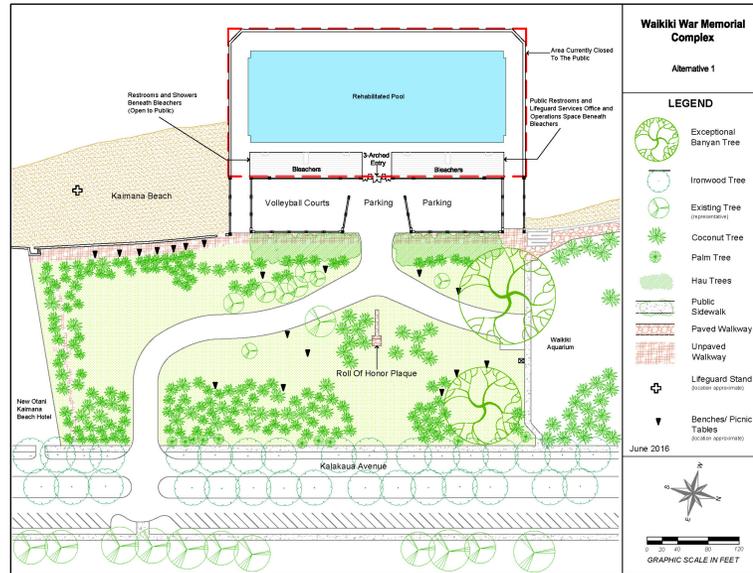
- Reconstruction of the pool including pool deck, supporting piles, and portions of outer seawalls.
- Repair or reconstruction of the bleacher structure.

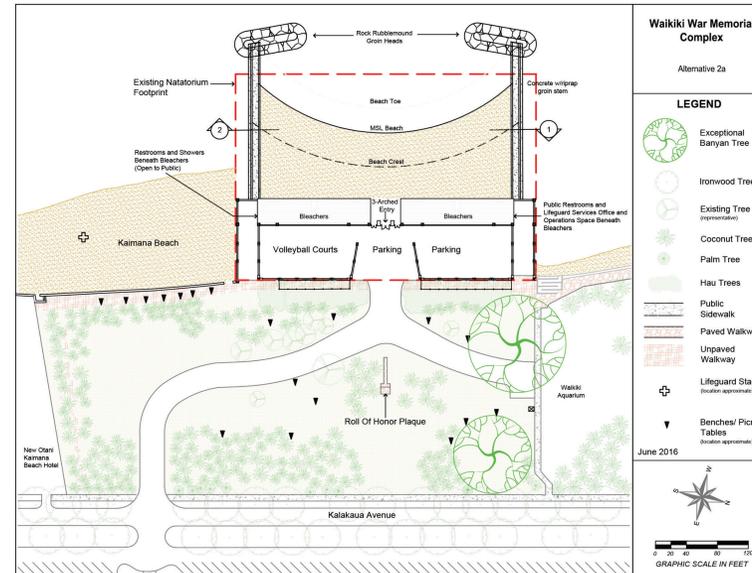
### 2a: Two equal-length groins extending outside the existing Natatorium footprint.

- L-head groins stabilize sand fill.
- Two pile-supported concrete with riprap groin stems and rubblemound groin heads constructed on the reef flat immediately seaward of the Natatorium's makai seawall.
- Extension of the groins outside the existing Natatorium footprint allows for a small stable beach.
- Approximately 13,000 cubic yards of sand fill; 34,000 square feet (1.03 acres) of beach area above msl.
- No land side changes.

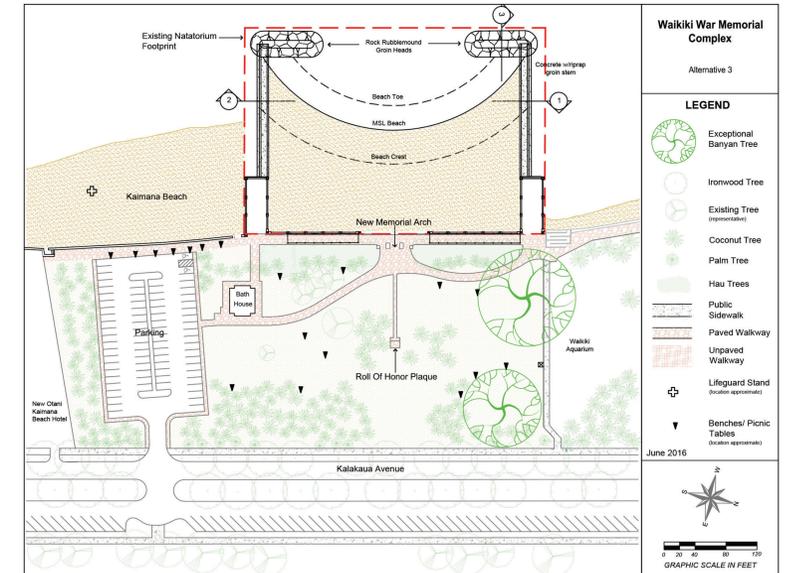
- Two equal-length groins within the existing Natatorium footprint
- L-head groins stabilize sand fill.
- Two pile-supported concrete with riprap groin stems and pile-supported groin heads.
- Due to soft sediments in the area, rubblemound groin heads would be constructed on pile-supported concrete platforms.
- In order to position the groins within the Natatorium footprint, groin heads have to extend into the swimming area.
- Approximately 10,500 cubic yards of sand fill; 50,000 square feet (1.1 acres) of beach area above msl.
- Replica memorial arch located inland from the existing Natatorium entrance, in alignment with the hau tree arbor.
- New bath house and consolidated parking lot.

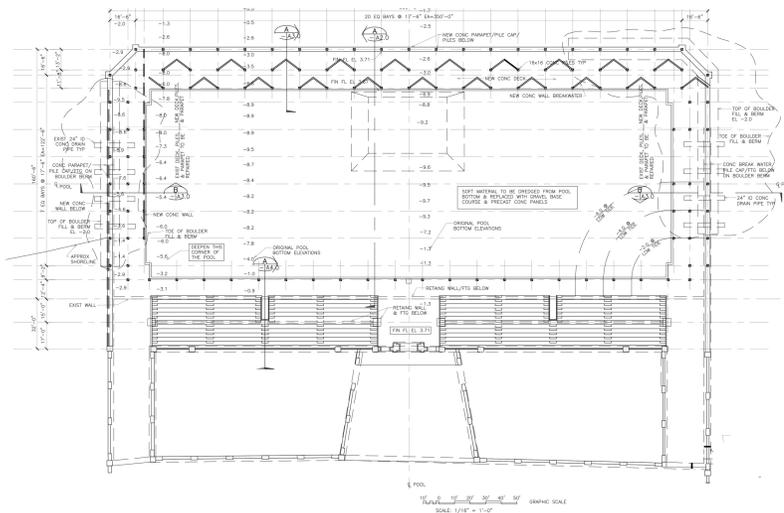
### Open system pool option for rehabilitated Natatorium

- Replacement of the swim basin's makai seawall with individual chevron units topped with decking.
- Chevrons serve as a breakwater to prevent wave action against the bleacher, yet allows for water to circulate in the swim basin.
- Excess water pushed back into the ocean via openings on the Ewa and Diamond Head walls.
- Bottom would feature a course gravel base atop precast concrete panels.

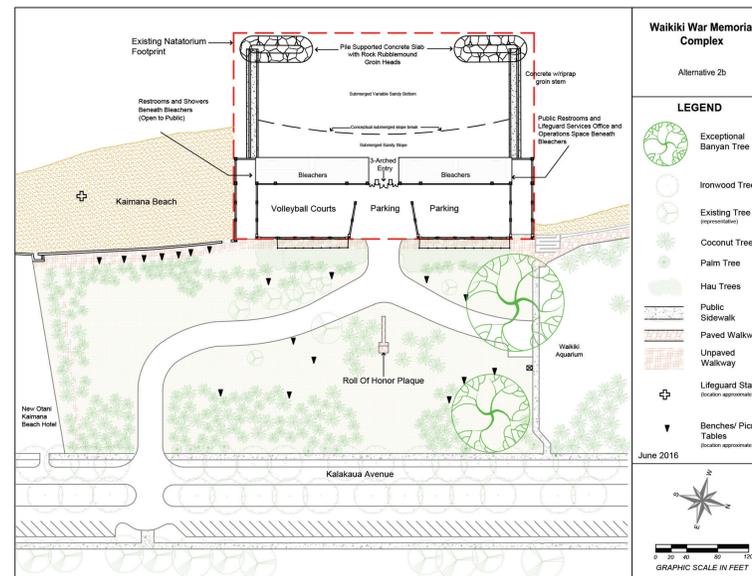
### 2b: Two equal-length groins within the existing Natatorium footprint.

- Two pile-supported concrete with riprap groin stems and pile-supported groin heads.
- Due to soft sediments in the area, rubblemound groin heads would be constructed on pile-supported concrete platforms.
- In order to position the groins within the Natatorium footprint, groin heads have to extend into the swimming area.
- Waves would impact more than 175 feet of the bleacher face, producing wave reflection, scouring, flattening of the foreshore slope and a likely chronic erosion problem.
- Retaining the bleachers with this groin configuration is not conducive to producing or maintaining a stable beach.
- No beach creation - initial sand fill along the bleacher face would likely migrate offshore, resulting in a submerged sandy area with no dry beach.
- No land side changes.
