City and County of Honolulu

2010 Wastewater Consent Decree

Annual Report

Year Four

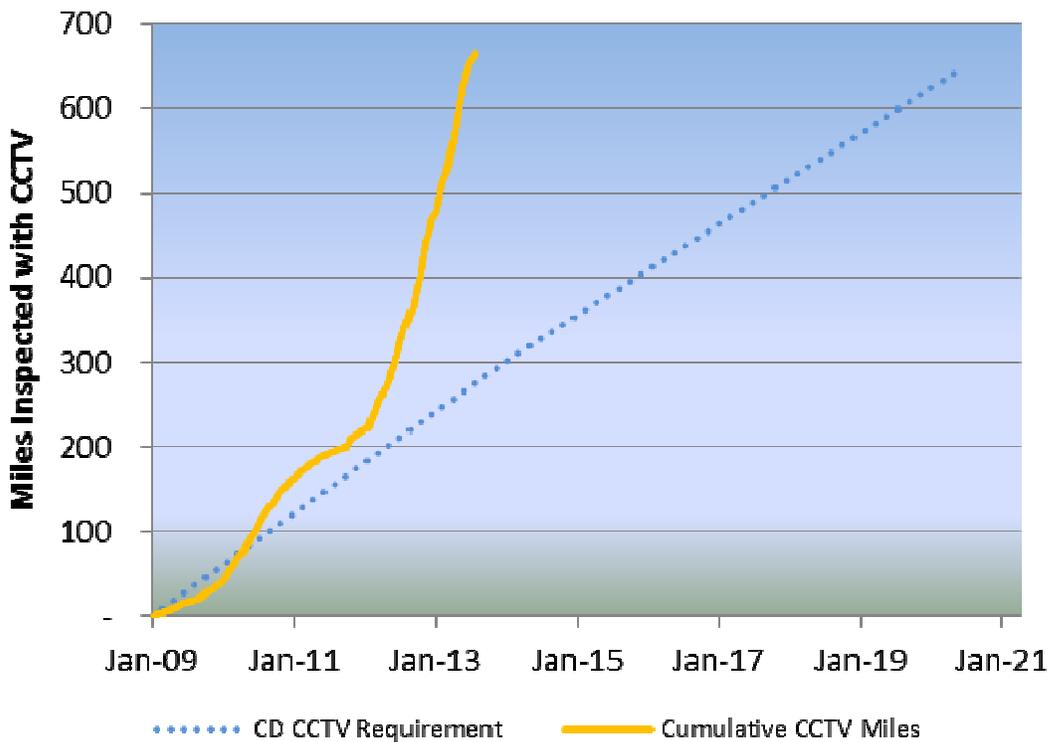
Figure 1. CCTV Inspection Miles through June 30, 2014

During the period from 1/01/2009 through 6/30/2014 CCH performed closed-circuit television (CCTV) inspection and condition assessment on approximately 689 miles of gravity sewer. The progress is charted in Figure 1.

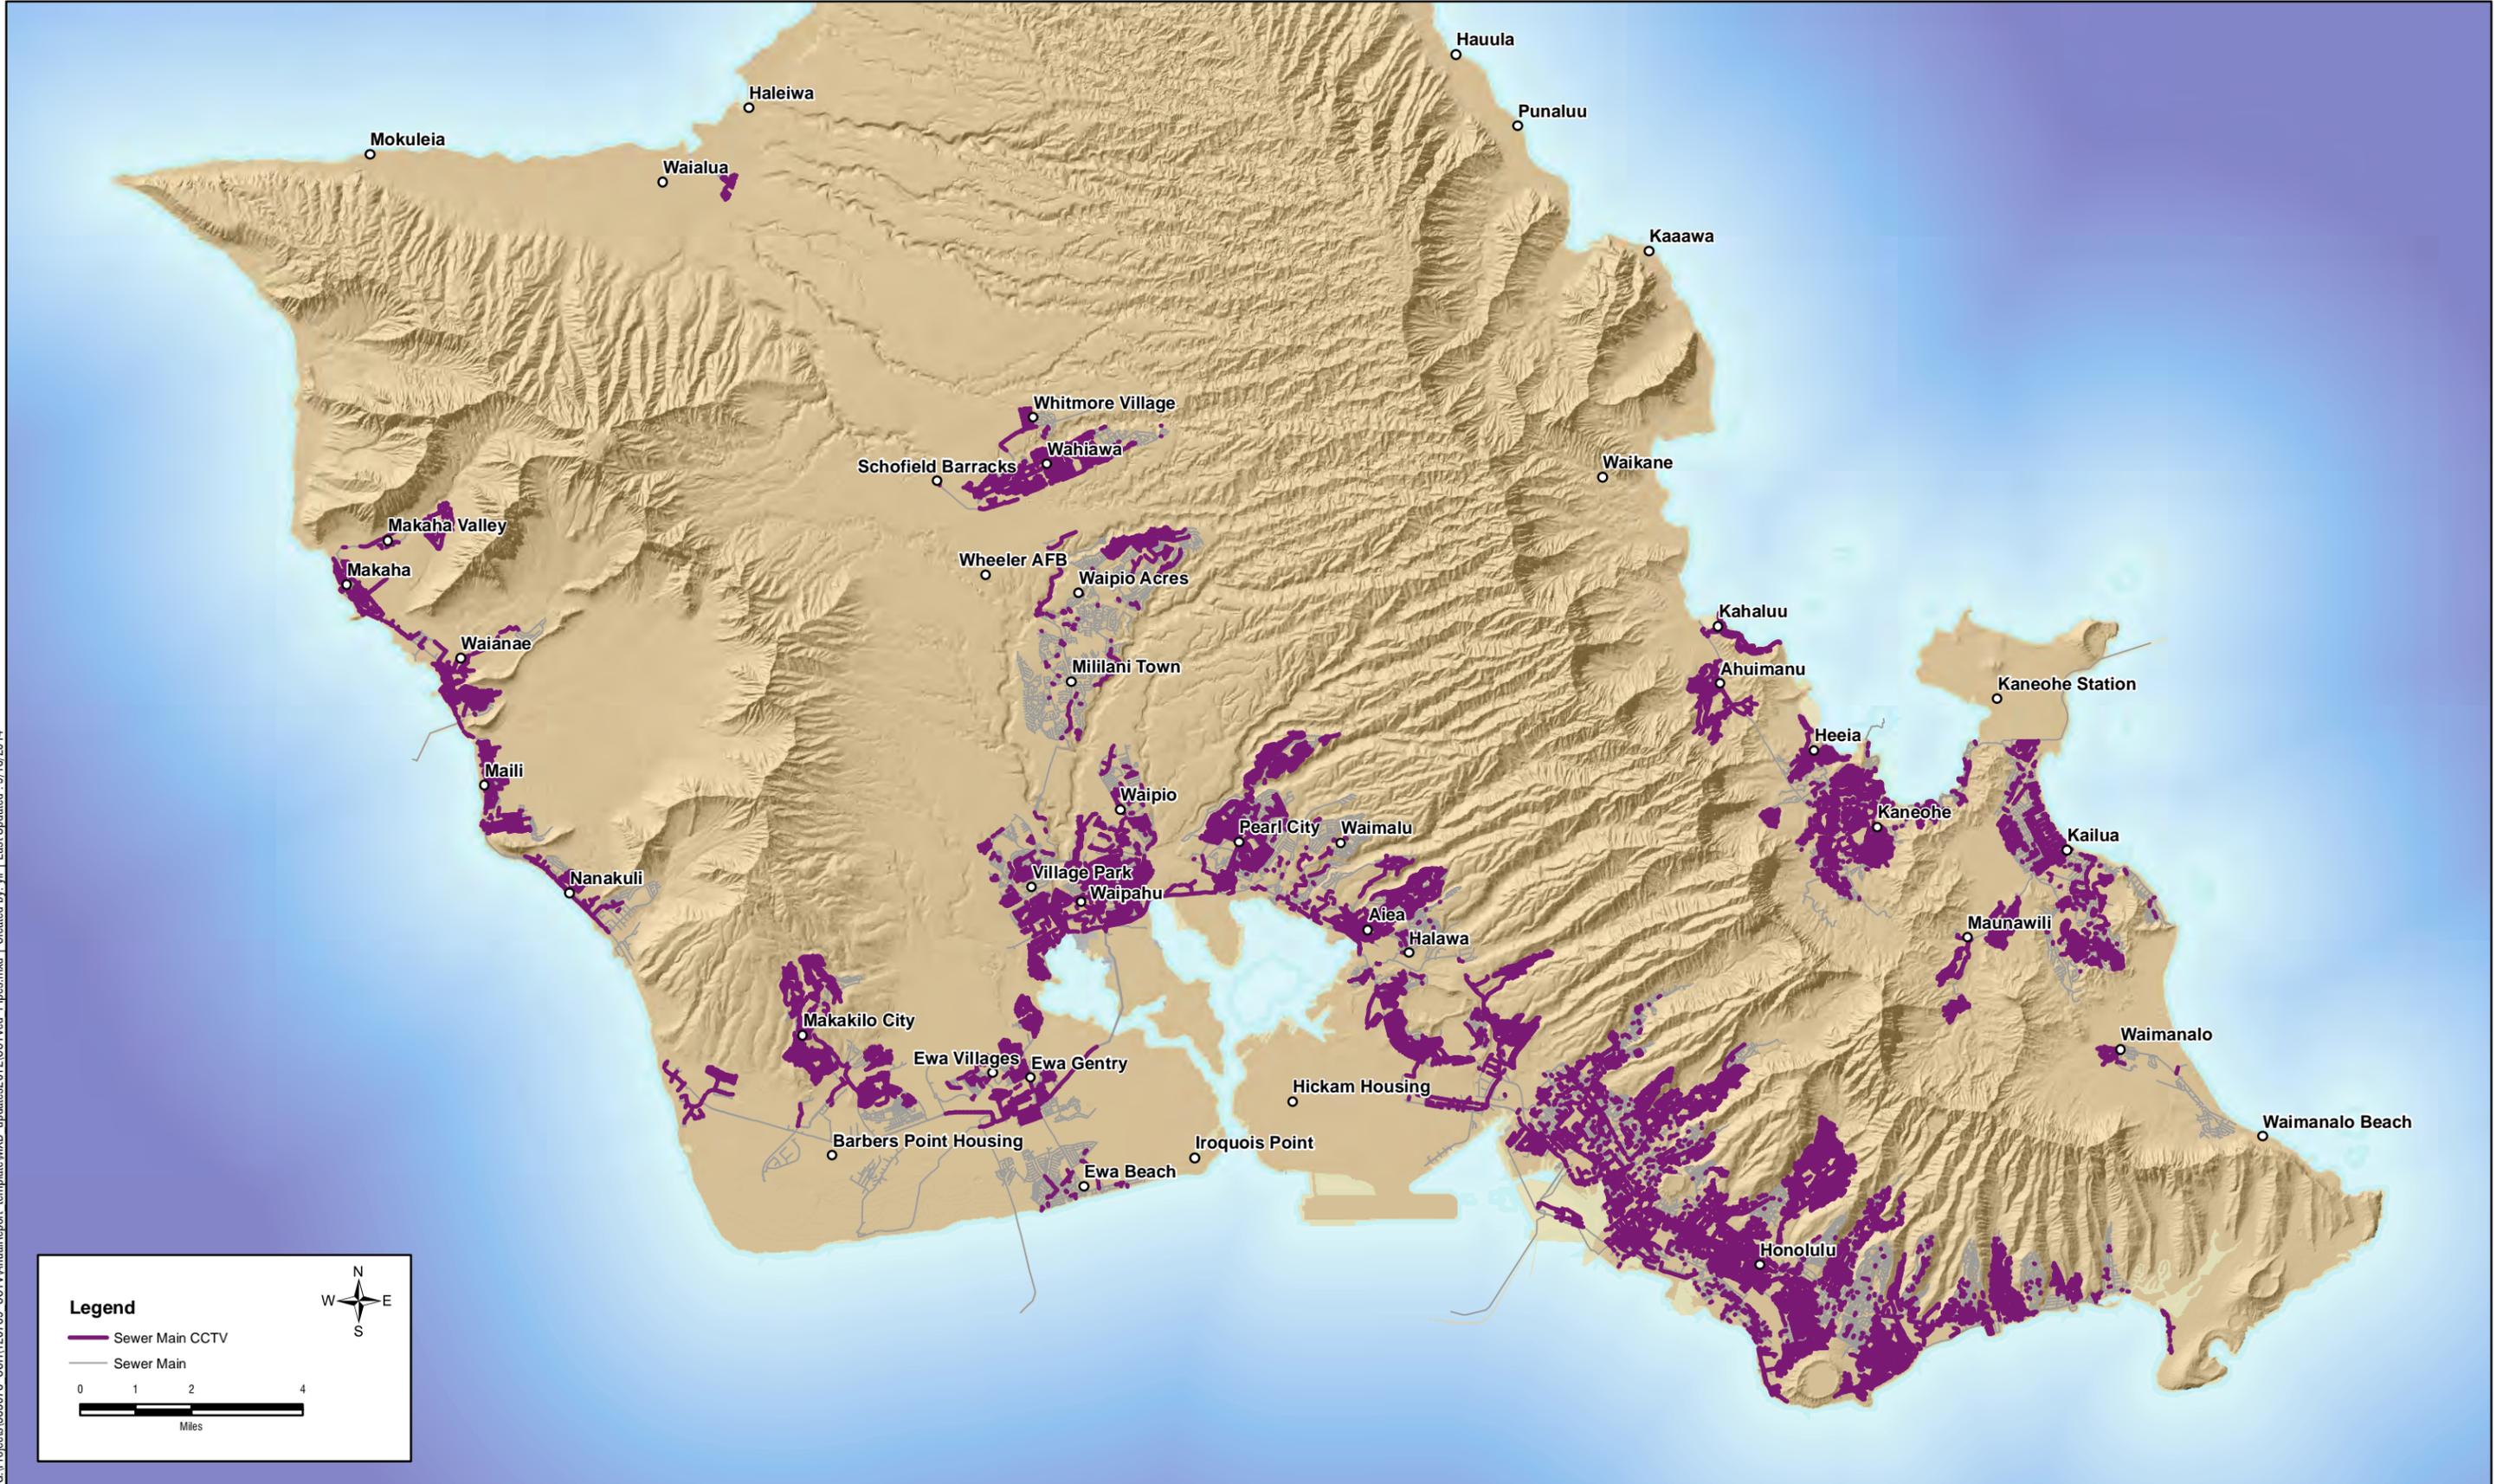
Gravity Sewer Condition Assessment (January 1, 2009 through June 30, 2014)

Figure 2 shows the pipe segments that have been inspected using CCTV since January 1, 2009.

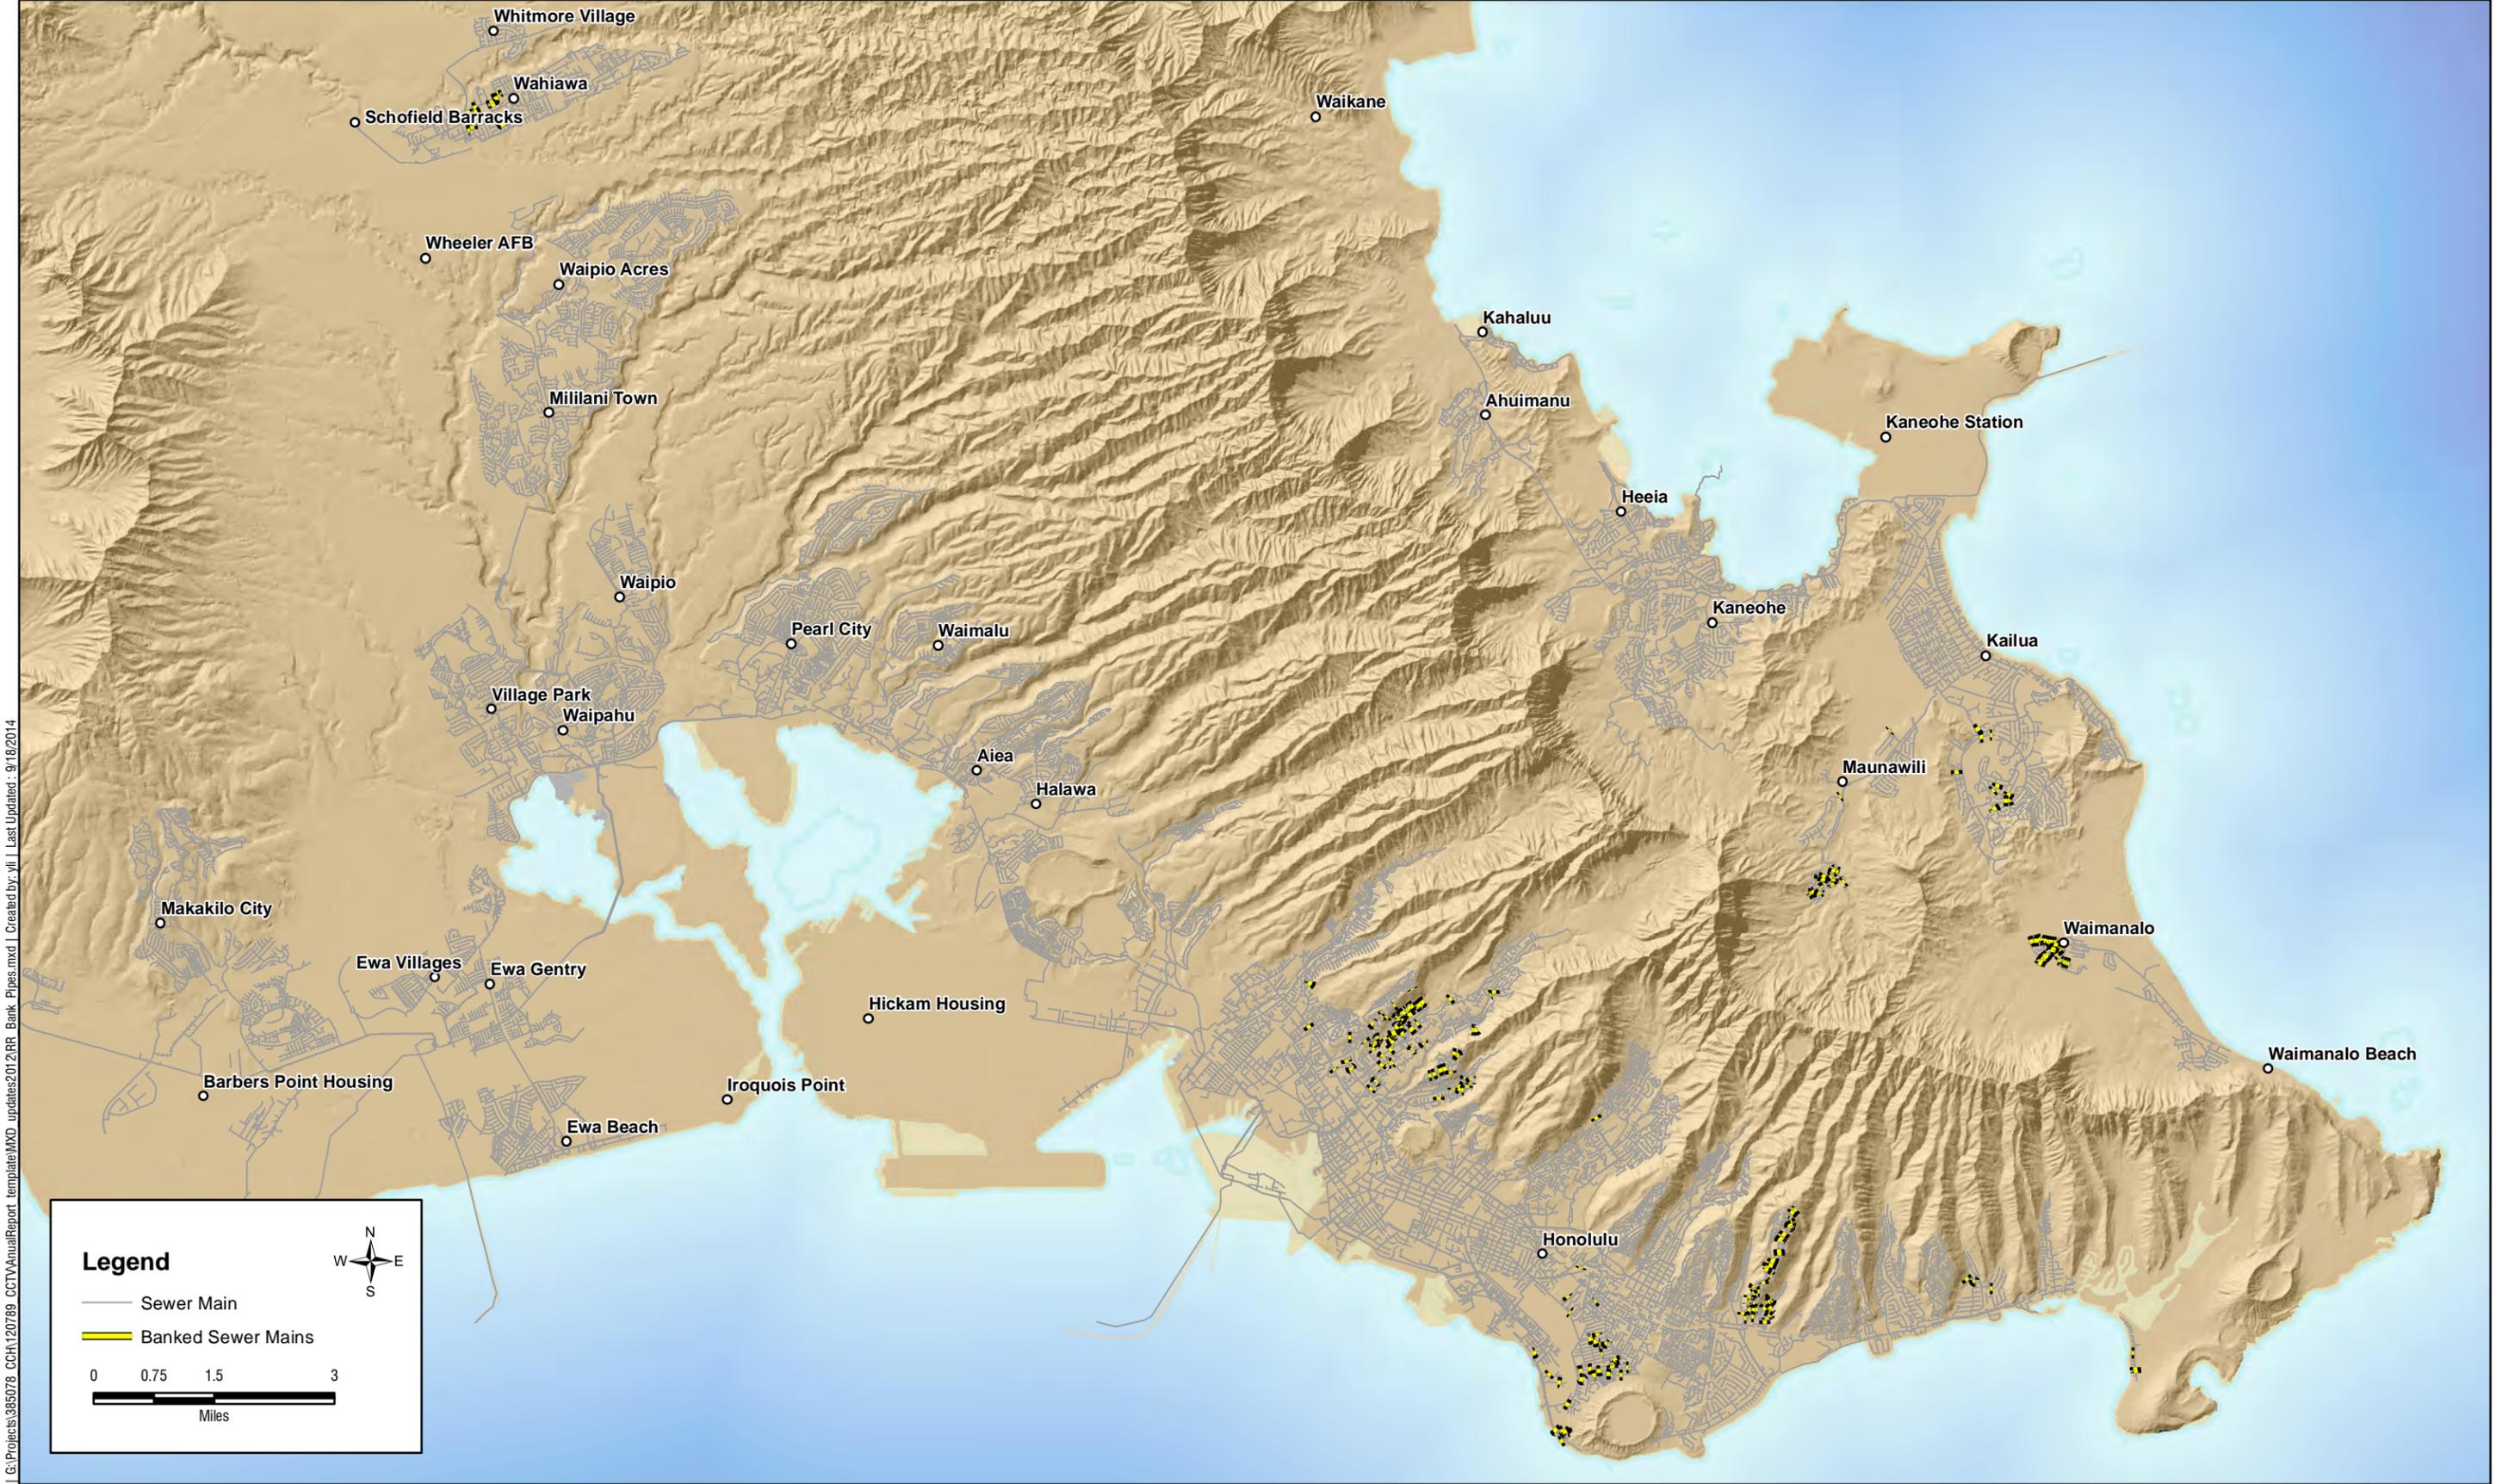
Pipe Segments Proposed for Addition to Rehabilitation and Replacement Bank

Figure 3 shows the specific sewer segments identified in Attachment A.

CCH maintains a database of sewer segments addressed through rehabilitation and replacement projects. A report from this database is shown in Attachment A. For projects that are not identified in CD Appendix H, CCH is allowed under CD Paragraph 20.e to bank the additional miles of gravity main sewer addressed through rehabilitation and replacement projects. Banked miles can then be used towards meeting the requirements of Years Four through Ten. Through the end of Year Four, there were 38 miles that qualified for this purpose of which 11.5 miles were applied towards the Year Four annual mileage requirement, leaving 26.5 “banked” miles.

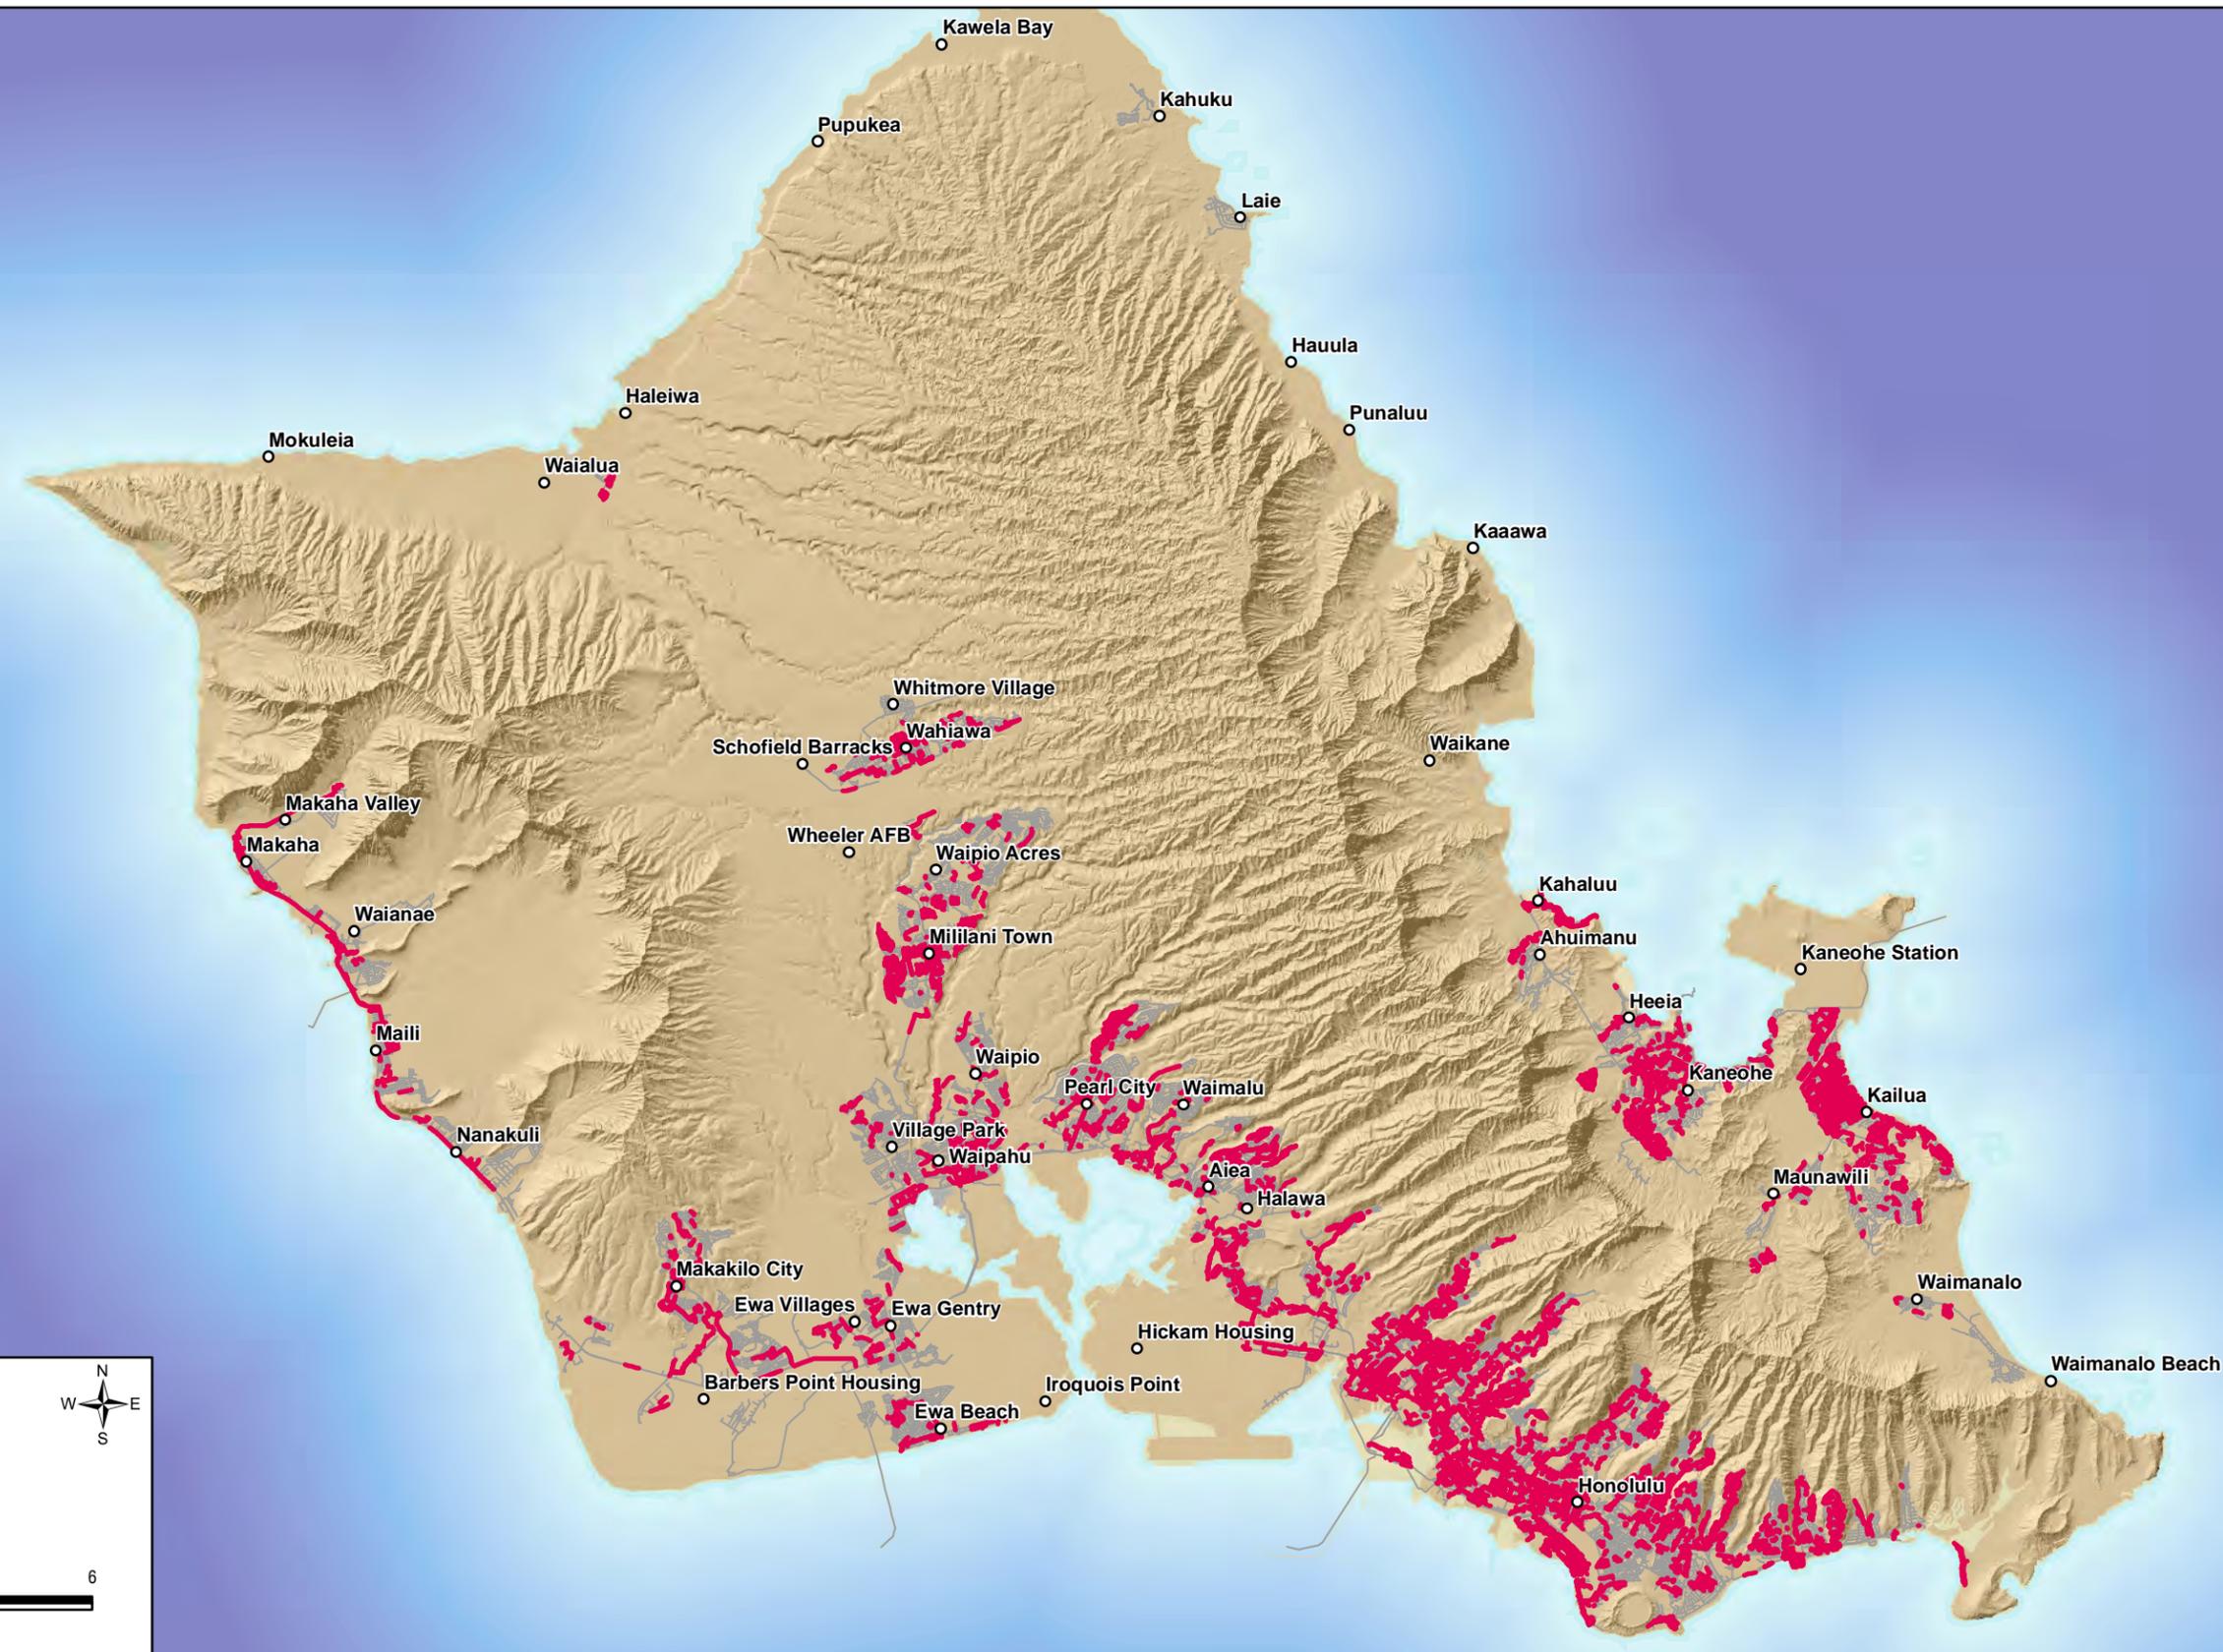
Figure 4 shows the pipes included in the gravity sewer cleaning program for Year Four.

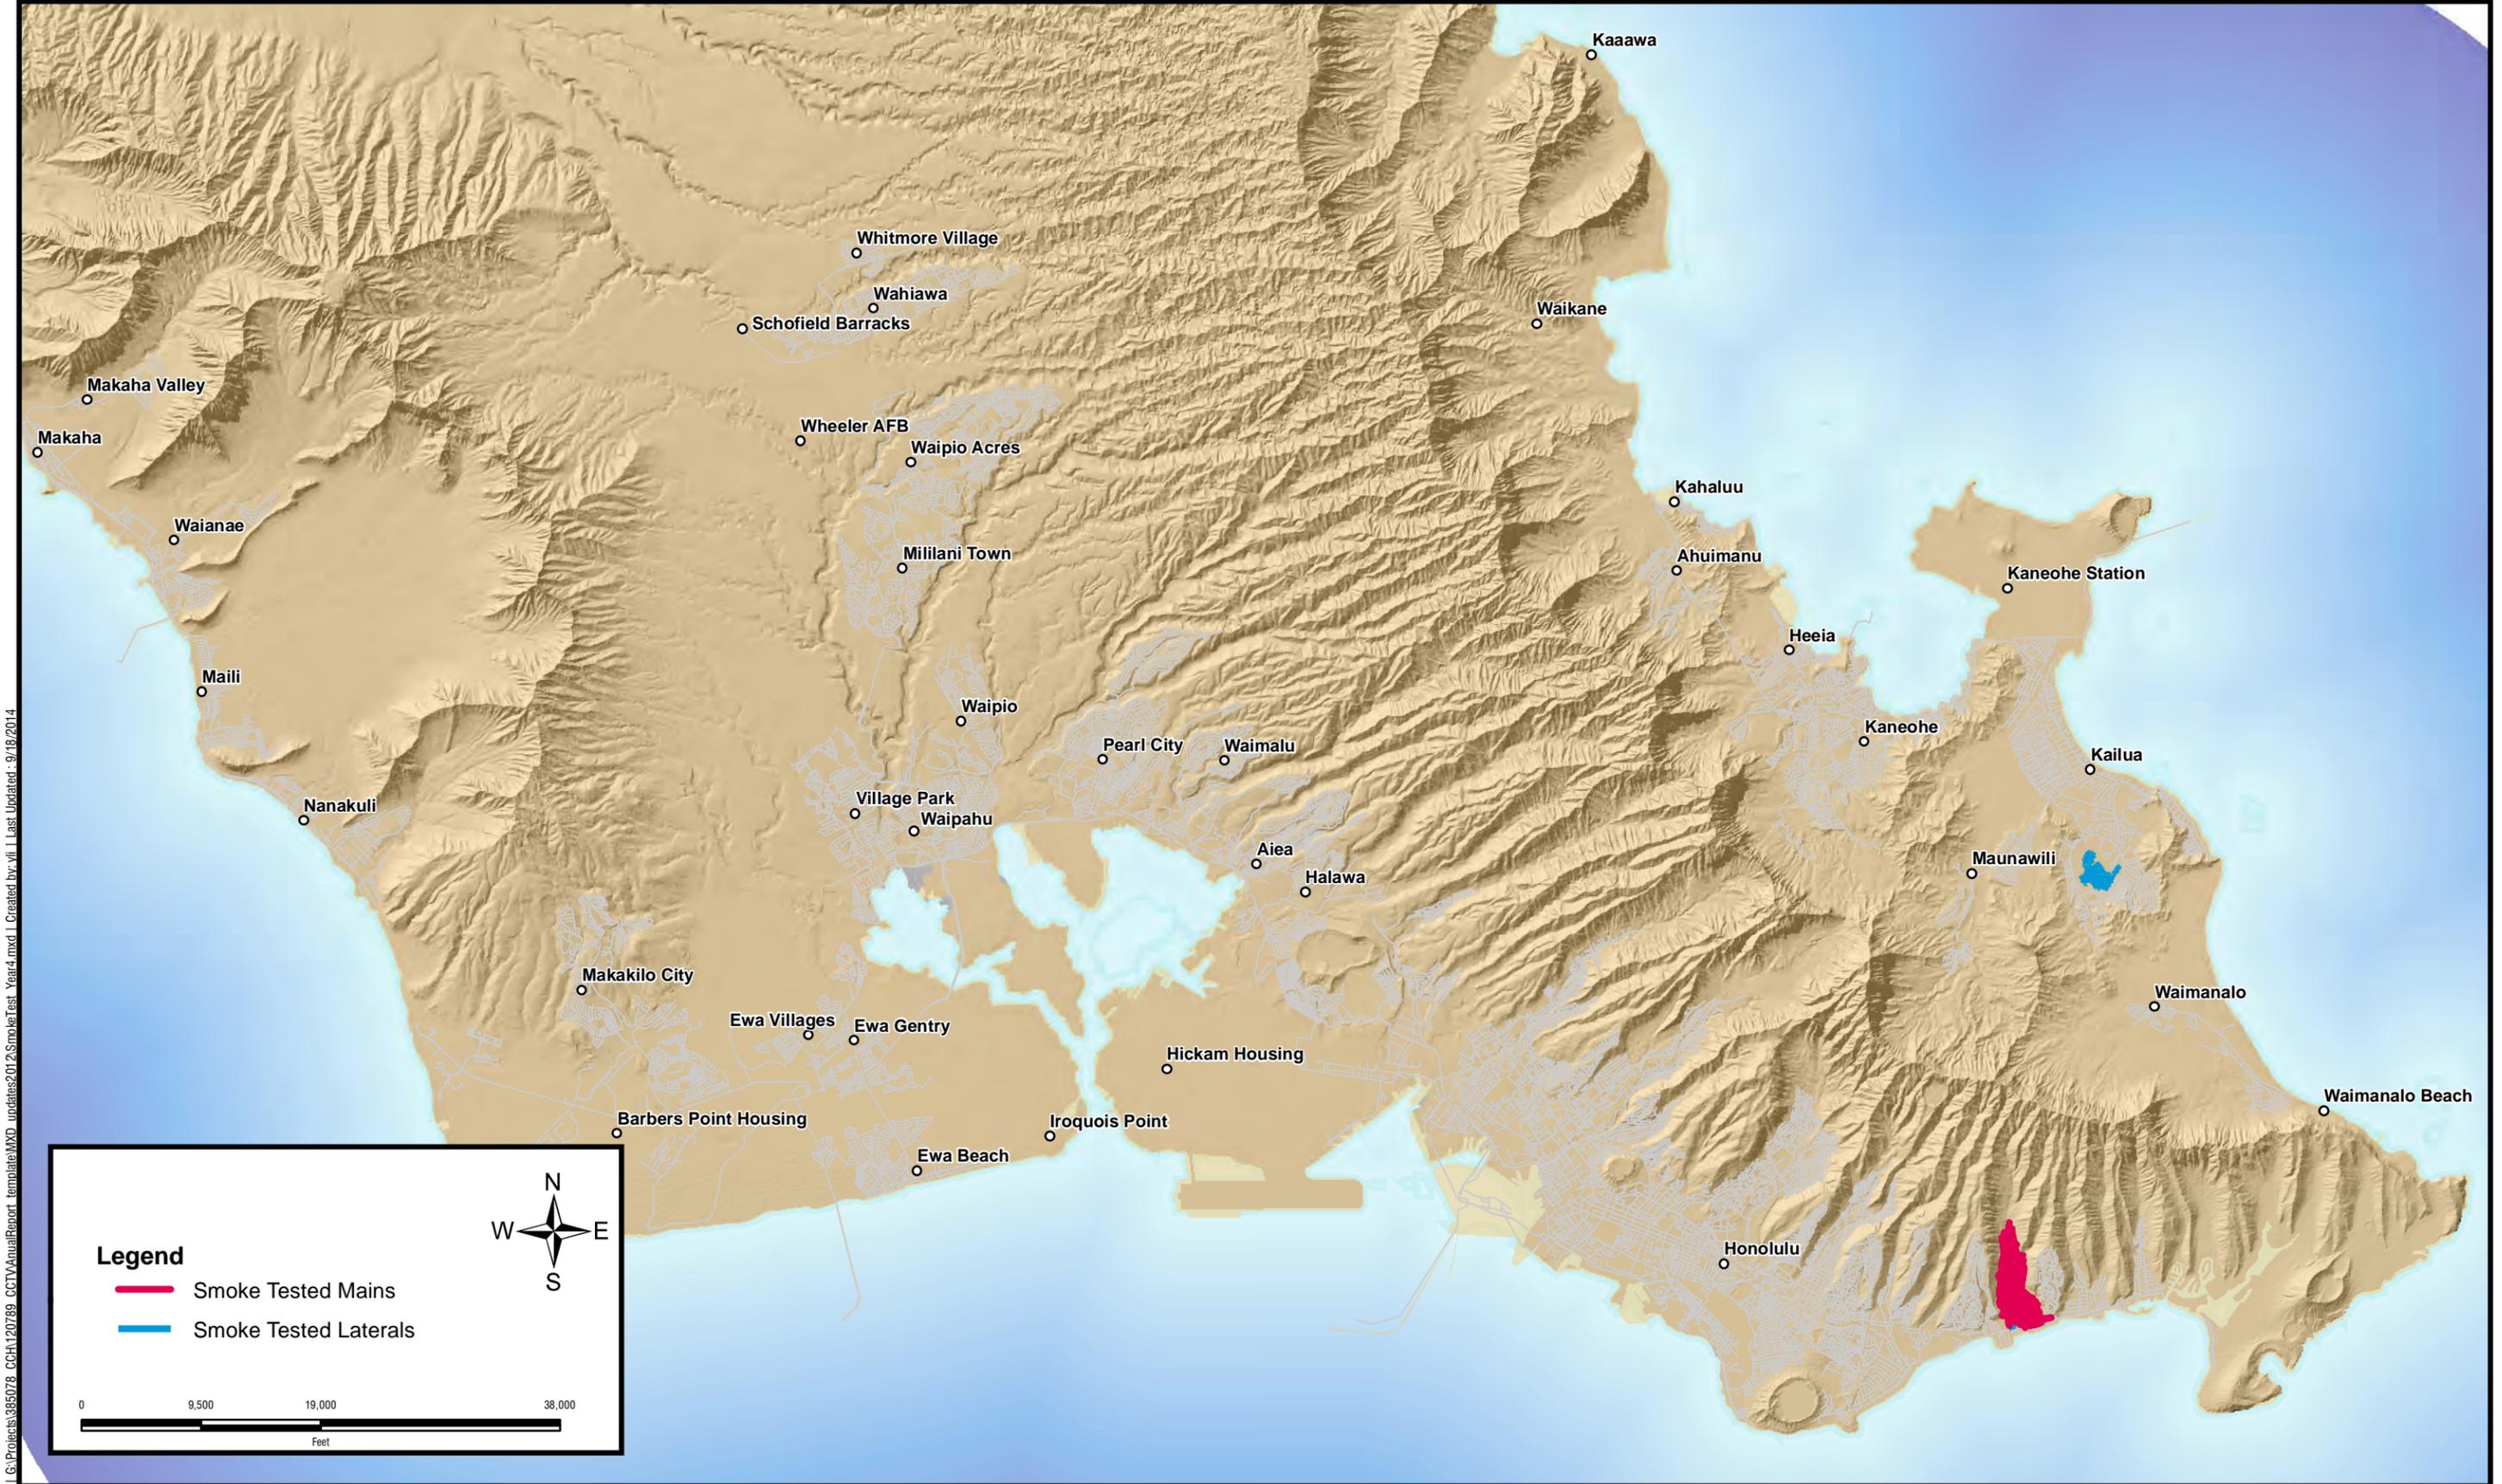
Figure 5 shows areas of smoke testing performed in Year Four.

During Year Four CCH identified 91 improper connections through the smoke testing program. Responsible parties are in the process of being notified to conduct corrective actions.
